## ARCHITECTURAL RESOURCES: DESCRIPTION AND EVALUATION

### Bellvue Farmstead (N-3975)

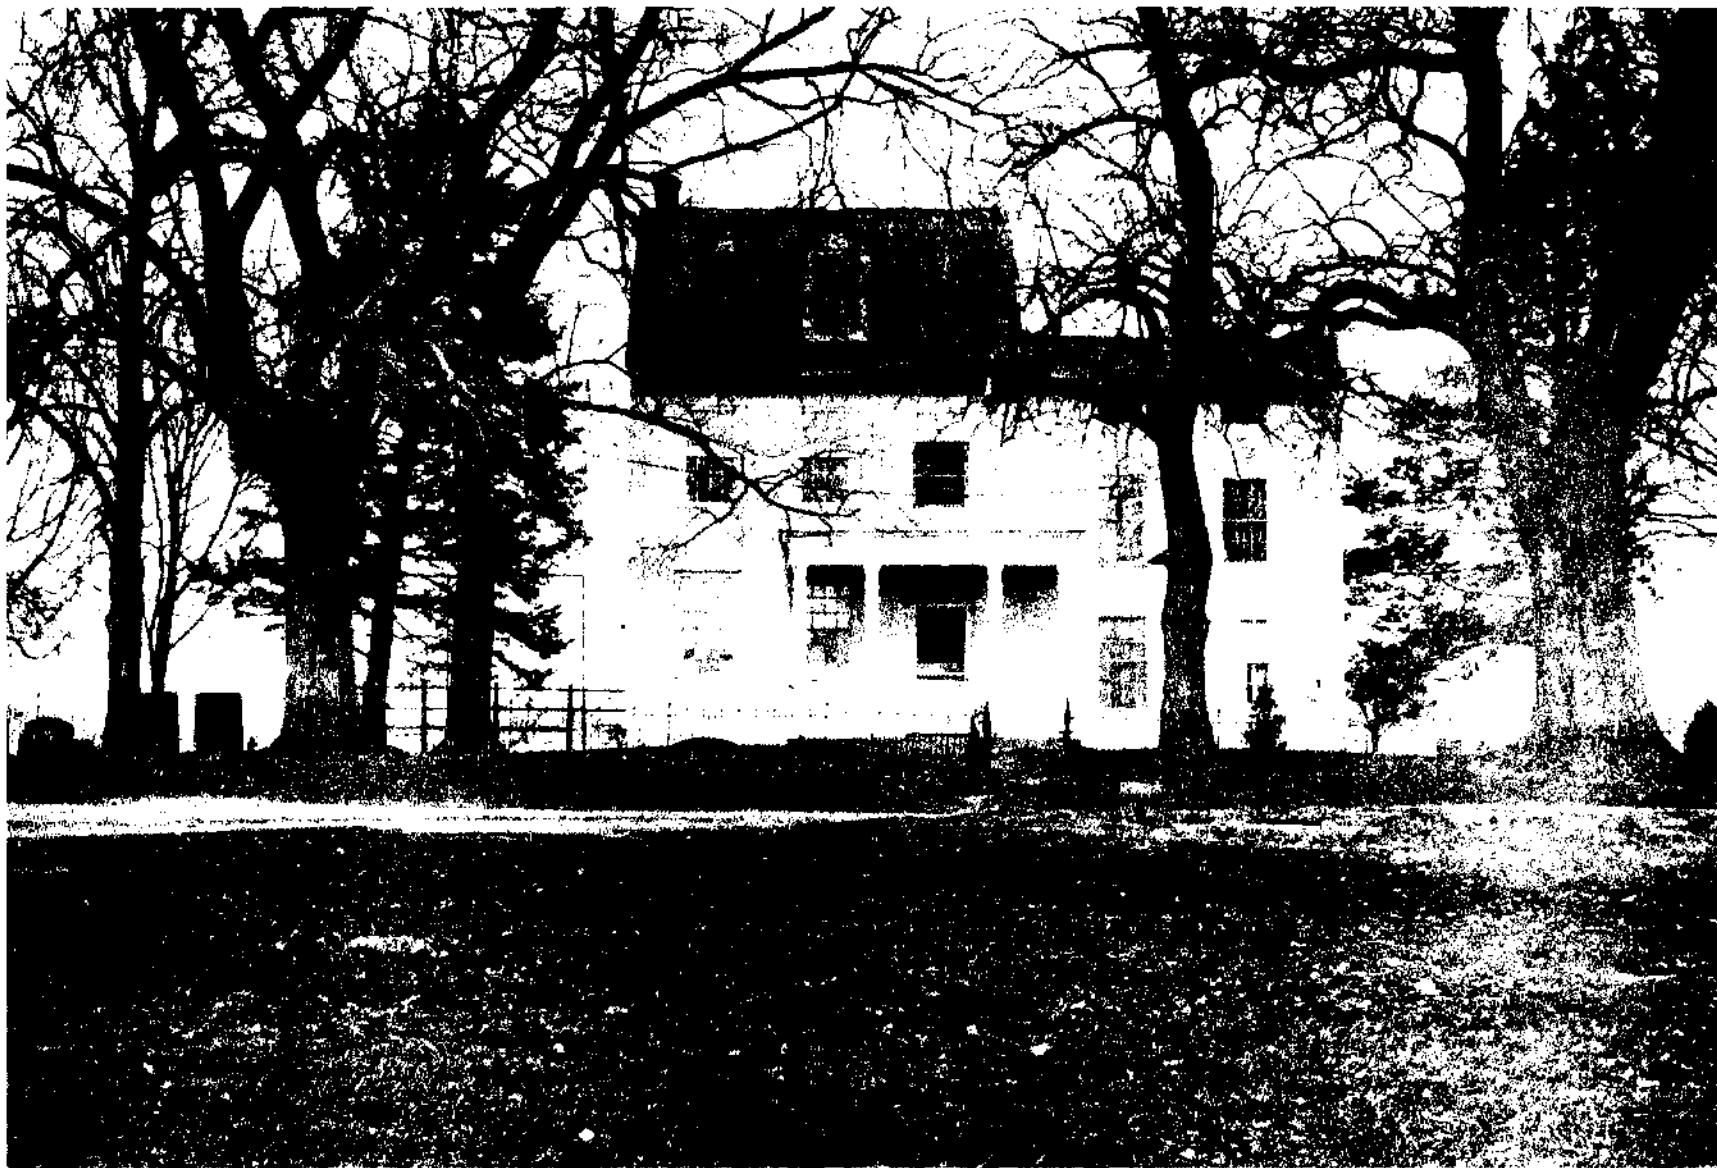
PLATE 2: Bellvue Farmstead, View of Farmhouse Looking North

The farmhouse (Plates 2 and 3) oriented perpendicular to Route 896 and facing south, exhibits three major construction phases. Earliest (prior to 1792) is a 2-1/2 story, side-gable side-hall unit of painted Flemish bond brick on a high brick basement. The three-bay facade features 12/12 double hung sash in molded surrounds above thick timber sills. On the west side the

sash are 9/9, set within segmental-arched openings. The entrance, which has a five-light transom and molded surrounds, is sheltered by a wooden porch with square posts, flat roof, concrete floor, and applied trim. The standing-seam metal roof features an interior gable-end brick chimney on the west, and boxed eaves with cove molding. The north wall of the house may have once featured a pentroof, as is suggested by exposed floor joists within the rear addition.

The second, mid-19th century phase of construction is represented by a large wood-frame double-pile unit built on to the east side of the brick section. The frame unit is also 2-1/2 stories, but as it lacks a basement the floor levels of the two sections do not correspond. The tarpaper-covered roof of the frame unit is flat over most of the structure, with short, shallow slopes on south and north sides. The east gable end is finished with a horizontal parapet or cornice. The unit is two bays wide (south elevation) and four bays deep, this depth corresponding to that of the brick section. Window treatment consists of 6/6 double hung sash set in flat plank surrounds with narrow drip shelves, and, at attic level, horizontal "eyebrow" windows, of which those of the east side are double hung. An entrance, out of line with the windows above it, is located in the east elevation.

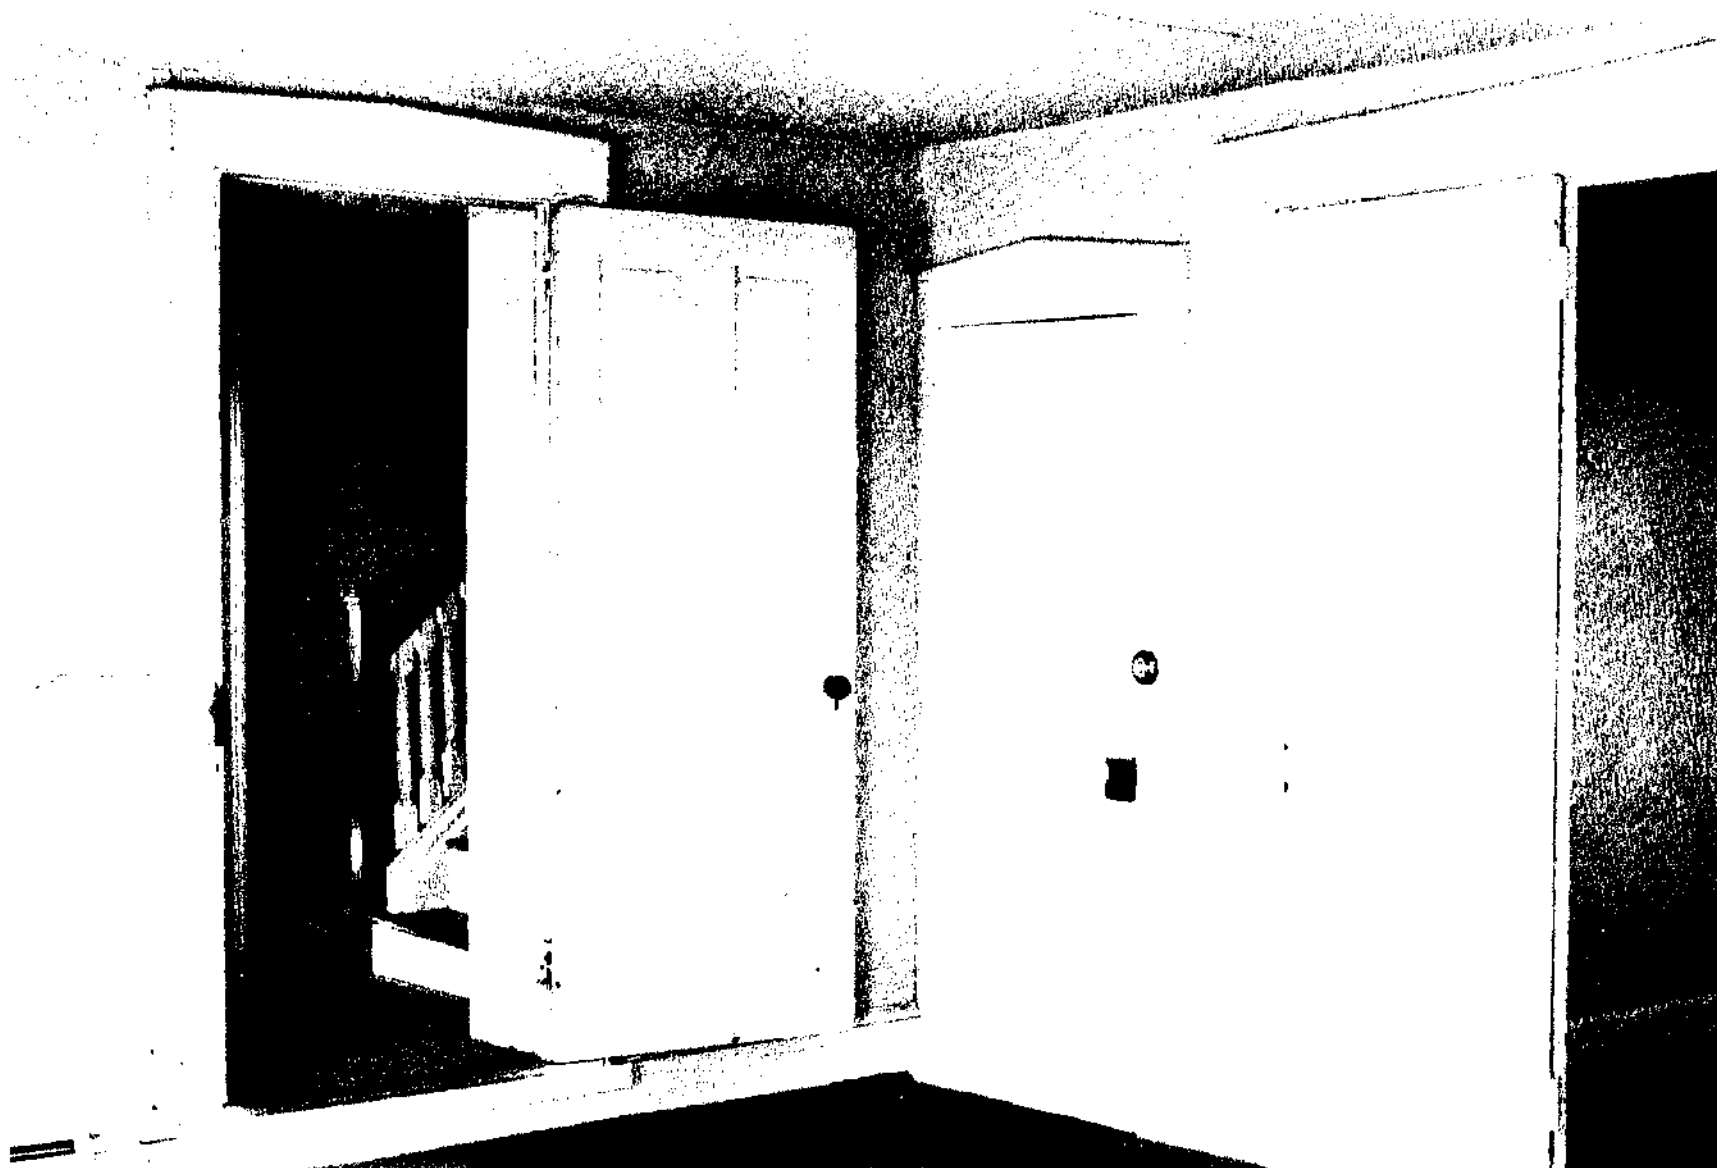
PLATE 5: Bellvue Farmstead, Representative Woodwork on First Floor, Frame Section

The main floor of the frame unit contains two large rooms connected by a very wide doorway fitted with four-panel double folding doors. Each room features a fireplace, neither of which have mantels or are functional. The woodwork is of a simplified Greek Revival type in which the tops of the window and door

surrounds, edged with a thick half-round molding, are shaped as very shallow triangular pediments (Plate 5). This same treatment, less the molded edge, is repeated on the second floor, which contains two bedrooms with filled-in chimney flues.

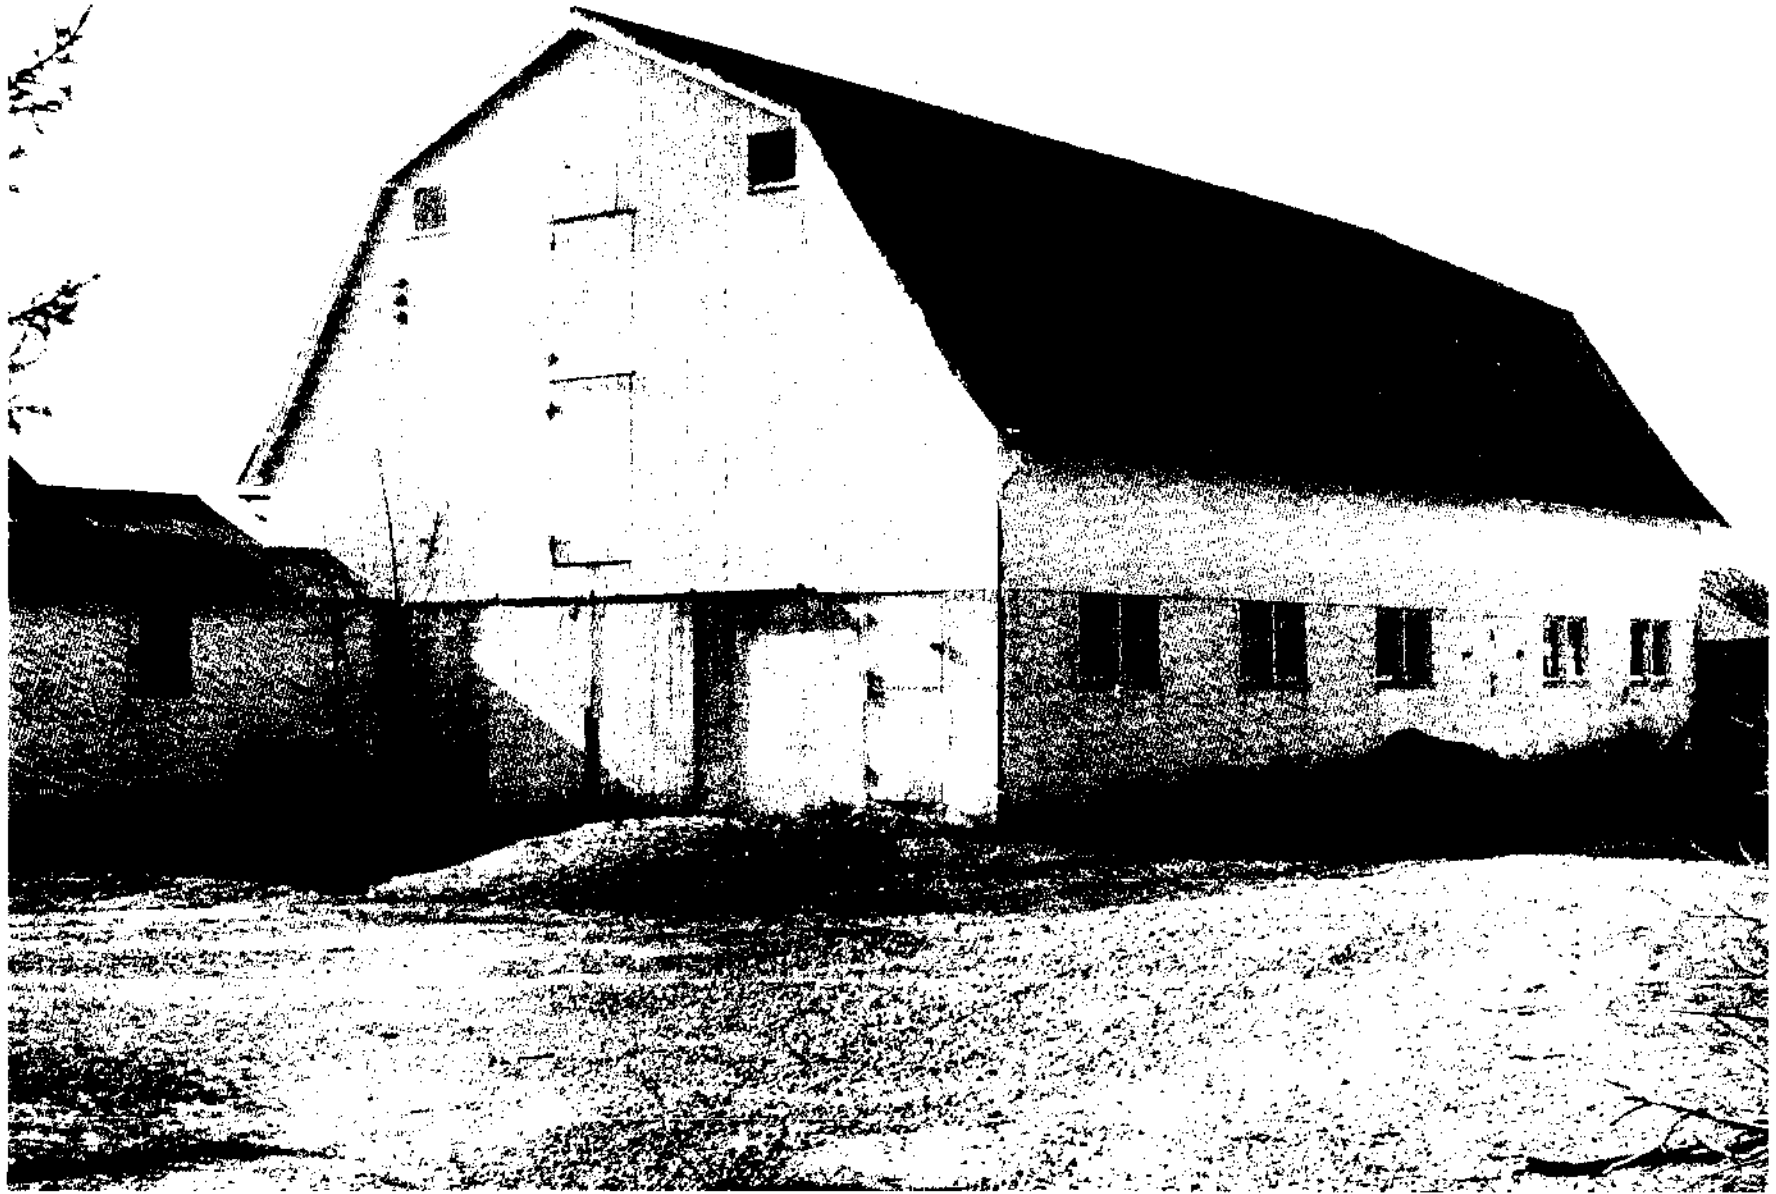
PLATE 6: Bellvue Farmstead, Dairy Barn, View to West

The agricultural buildings (Plates 6, 7 and 8) are located southwest of the farmhouse. Largest is a gambrel-roofed dairy barn constructed of concrete block with vertical plank siding on the loft level. Nearby to the south is a one-room wood frame structure with gable roof, vertical plank siding and six-light fixed sash windows. Beyond this structure is a frame barn with corrugated sheet metal gable roof and vertical plank siding. Three vehicular bays have been cut into the south side for machinery storage. A machine shed of concrete block construction, open on the south side, is attached to the west end of this barn. The corncrib, a large gable-roofed structure the vertical boarding of which is slightly spaced for ventilation, is the southernmost structure in the complex.

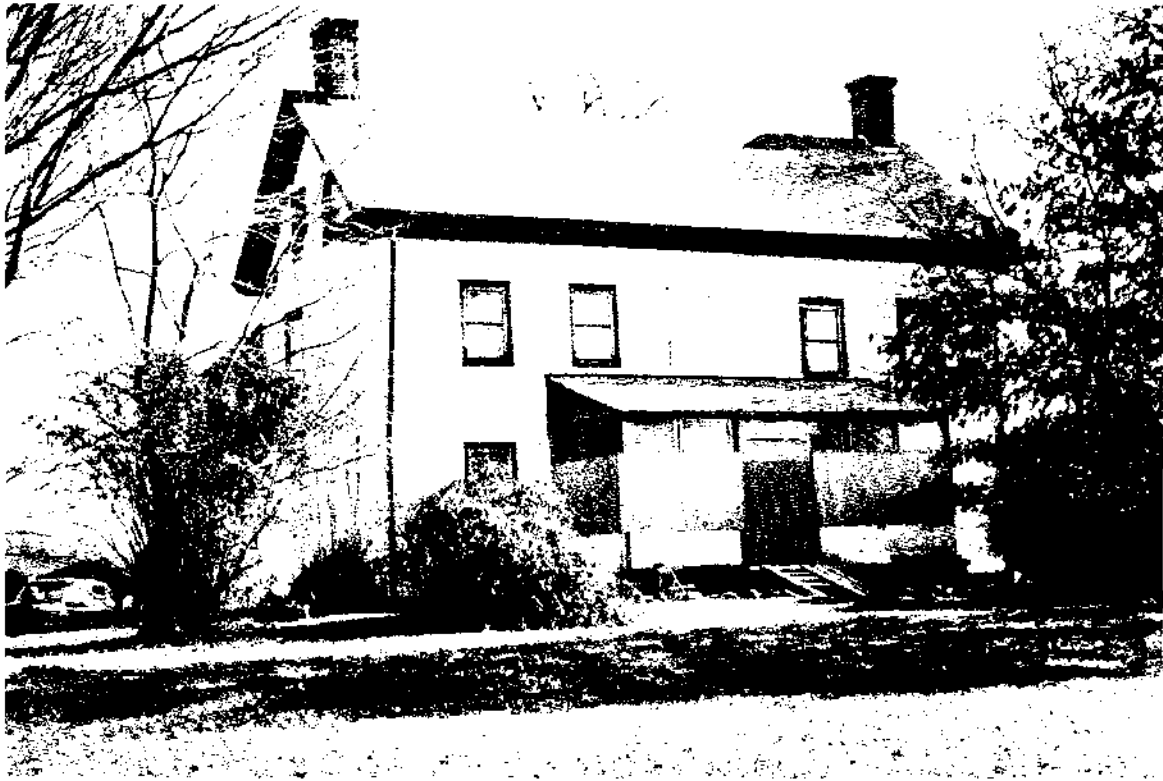
PLATE 9: DeShane — Paxon House, View Looking Southeast

The house consists of a 2-1/2 story side-gable single-pile main block with a two story rear ell (Plates 9 and 10). The house

is of wood frame construction, clad in gray-tan artificial shingling, on a raised masonry foundation coated with concrete. Tall brick chimneys with corbelled caps are located within the gable ends of the main block. The roof is covered with composition shingles, and on the main block has molded cornices with partial returns.

The facade is divided into five bays. The fenestration is slightly asymmetrical, suggesting either that the center bay was repositioned or that the existing main block is the product of more than one building episode. Windows in the facade have 2/2 double hung sash in narrow molded surrounds, as do those in the two-bay side elevations. Several 6/6 windows are present in the ell, the floor levels of which do not correspond to those of the main block.

On the front, the center three bays of the first floor, including the front entry, are hidden within a shed-roofed porch enclosed with plywood. A second shed-roofed porch, semi-enclosed with plywood and tarpaper, shelters the kitchen entrance located in the south wall to the ell. The interior was not accessible during this survey, as the tenant occupants were not at home on several attempts.

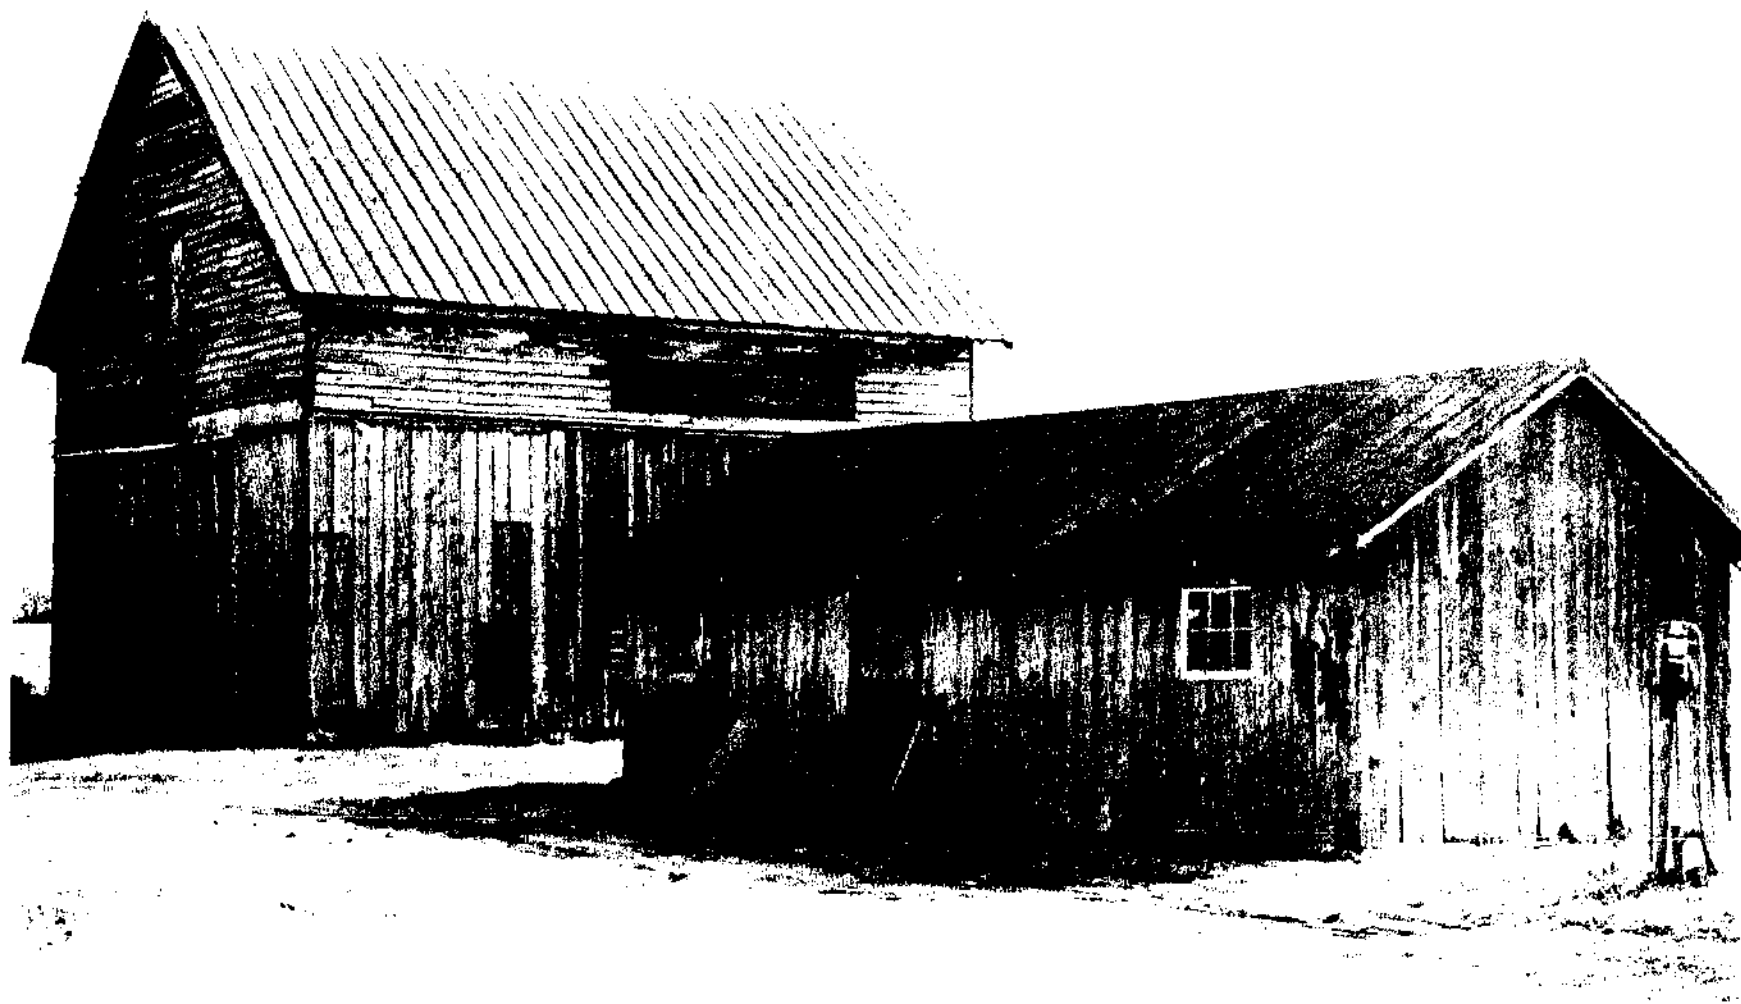
PLATE 14: Roger Williams (C. Boulden) House, Corncrib/Granary and Shed, View to Southeast

There are three outbuildings associated with the property. Largest is a timber framed crib barn or granary with vertical plank siding on the ground level and horizontal weatherboarding at loft level, covered with a standing seam metal front-gable roof (Plate 14). To the east is a long one-story wagon shed or stable with vertical plank siding, six-light fixed sash windows and side gable standing seam metal roof with projecting rafter ends. Almost directly opposite this structure is a machine shed of similar form, partially open on the south side. The fourth building, oriented perpendicular to the others at the east end of

the complex, is a large front-gable shed clad in corrugated sheet metal. The extent to which these structures are now used for agricultural purposes appears to be limited.

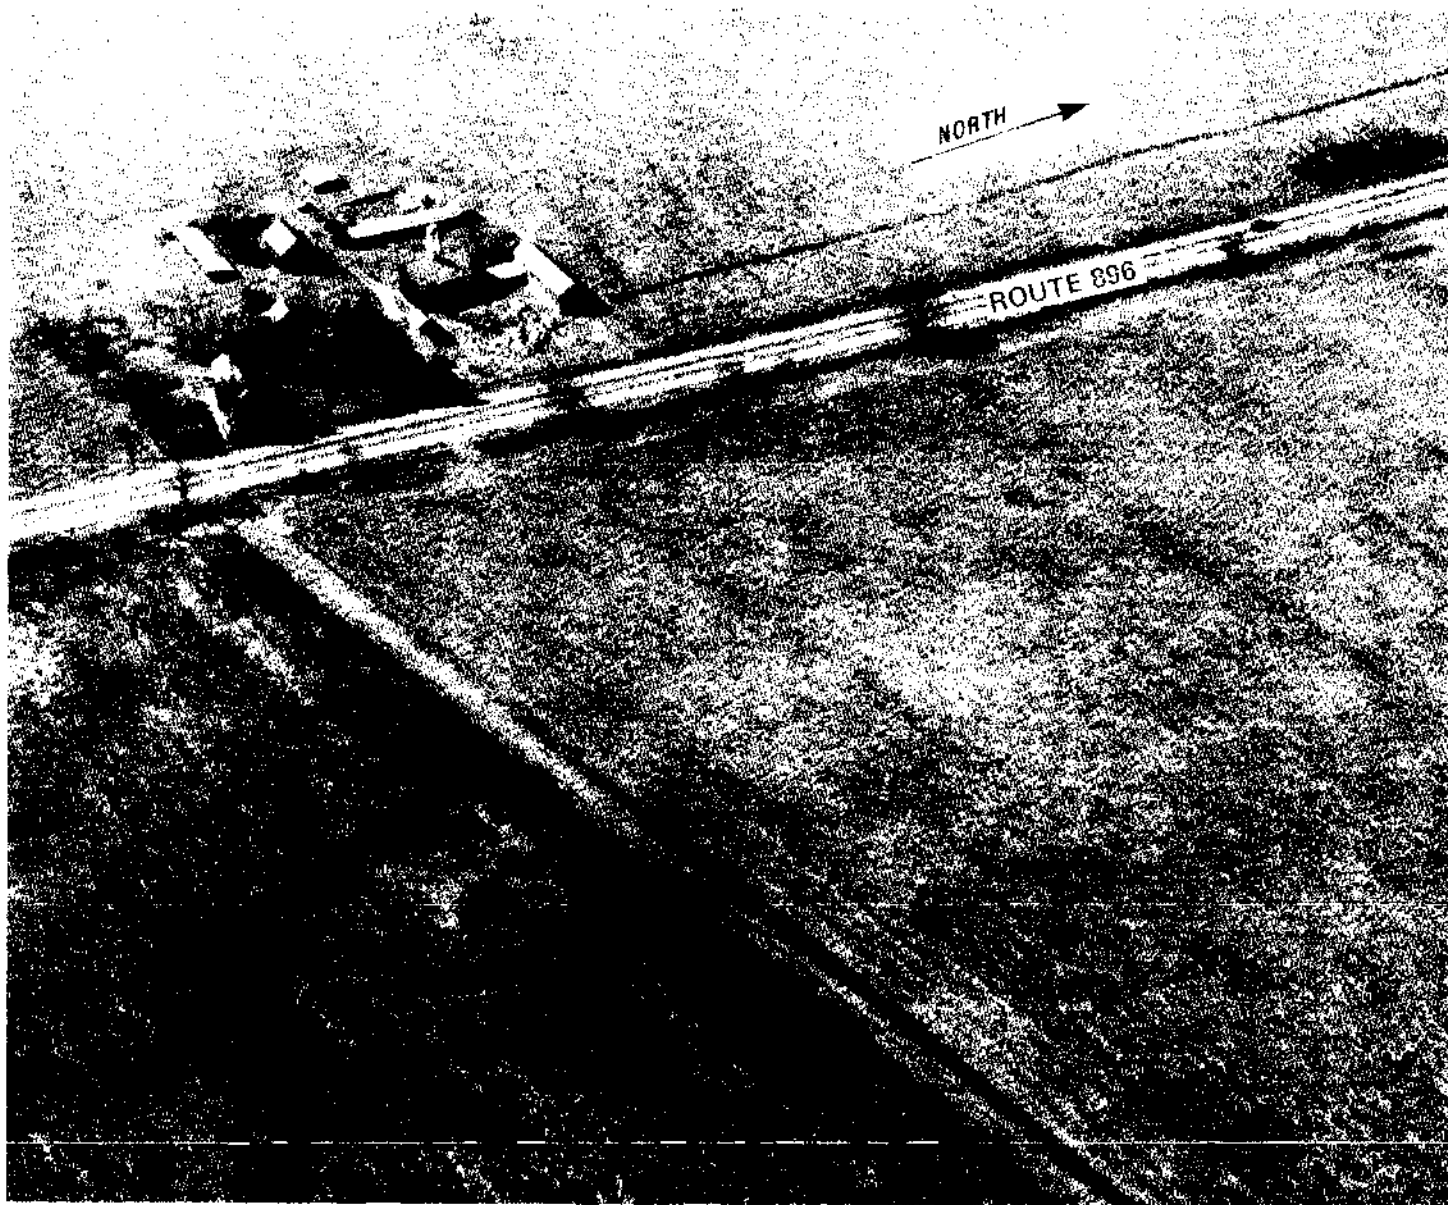
Description: The Cann farmstead occupies an area lying west of Route 896 and north of the New Castle and Frenchtown Railroad right-of-way. The agricultural complex includes a dwelling located near the railroad right-of-way, plus fifteen outbuildings lying northwest and north of the house. The house is set off from the outbuildings by unpaved lanes that enclosed the house yard, which is further defined by fencing and concentration of large coniferous trees on the north side (Plate 15).

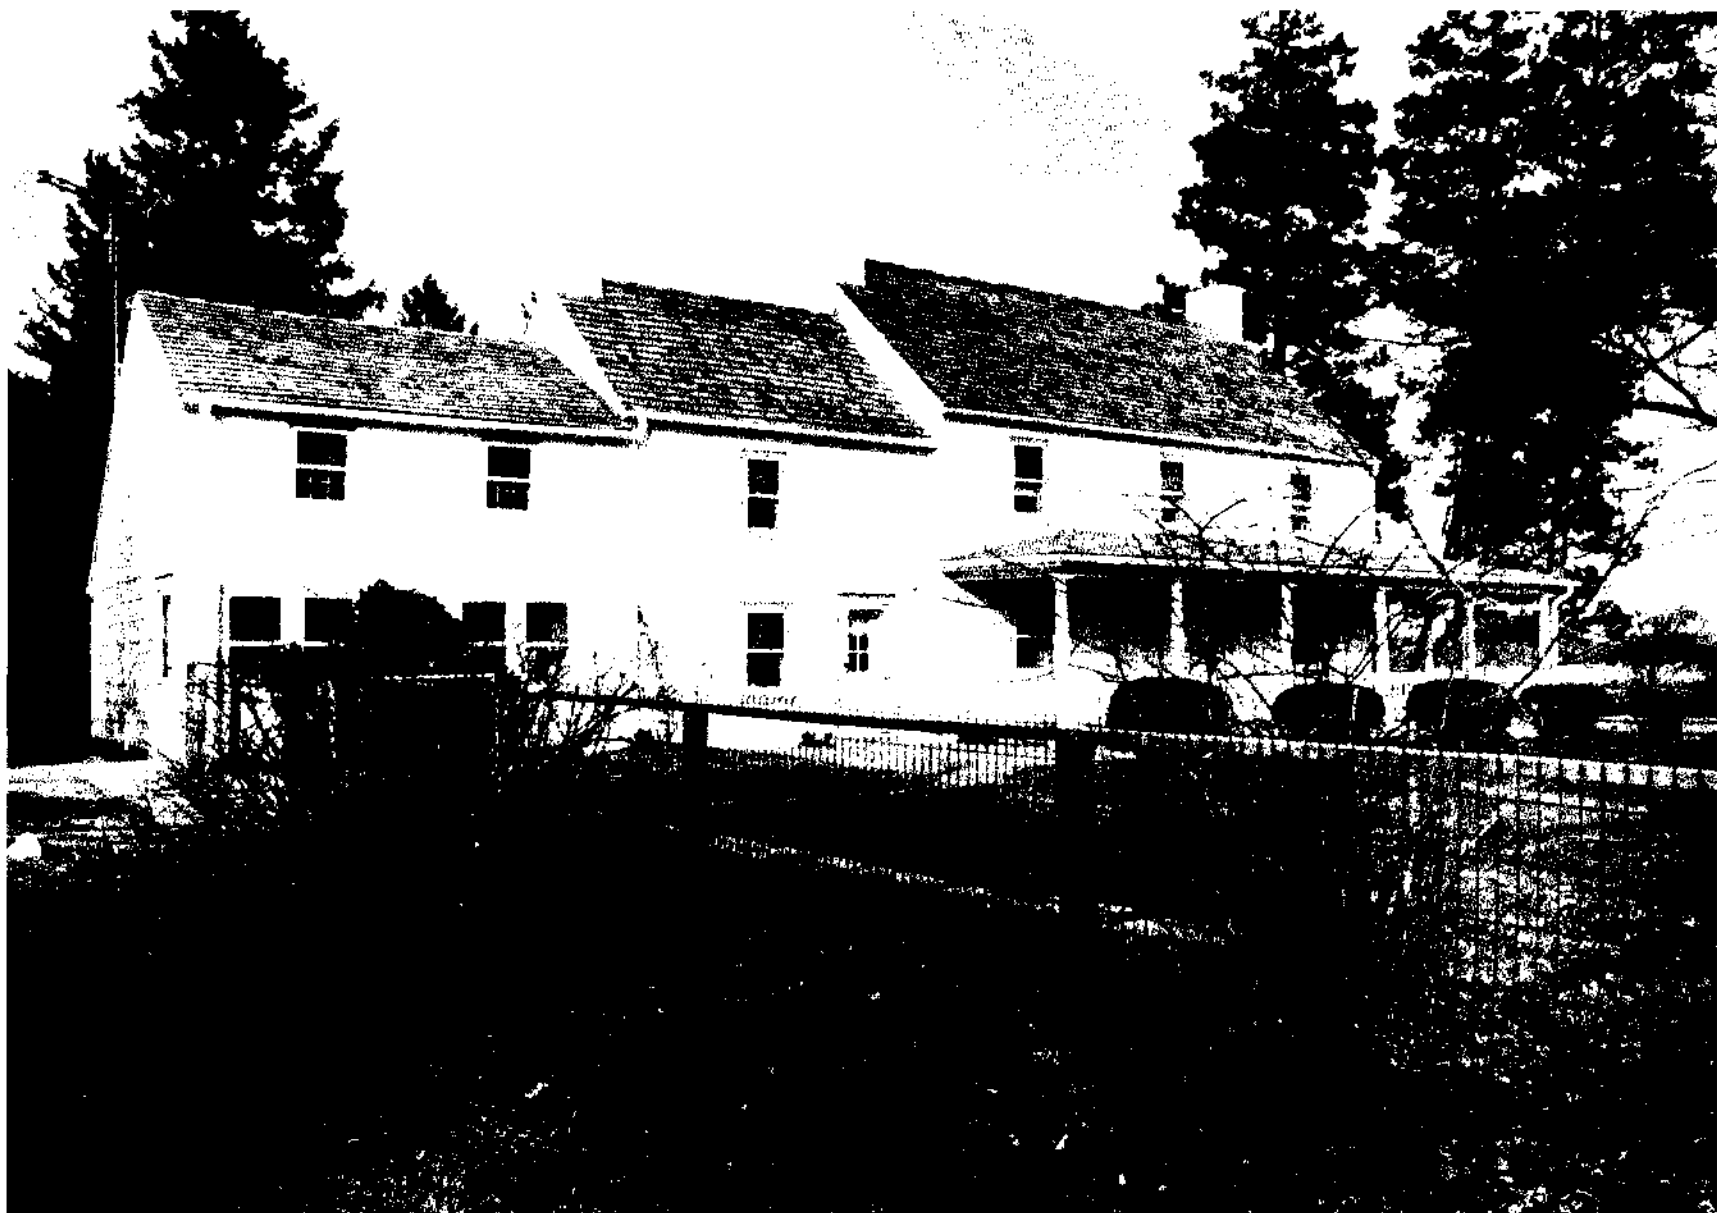
PLATE 16: Cann Farmstead, View of Farmhouse Looking Northeast

The farmhouse, which was largely completed prior to 1835, is composed of three side-gable single-pile units arranged in linear fashion and oriented to face south (Plates 16 and 17). The largest unit, on the east end, is a two-story stuccoed brick block with hall-parlor plan and rectangular brick chimneys rising out of each gable end wall. The front and rear elevations are irregularly fenestrated, with four symmetrically arranged openings on the first story and three on the second. In the two center bays of the facade are entrances framed with paneled reveals and beaded surrounds, opening directly into the "hall" and "parlor". At the southwest corner is an exterior bulkhead entry to the

cellar, which is completely below grade. Across the facade is a hipped roofed porch on a concrete slab with wooden Tuscan Doric columns.

The middle unit, also of stuccoed brick, is also two stories high, but with floor levels slightly below those of the easternmost unit. This middle section is two bays wide, with an exterior entrance, and contains one original room on each floor. The depth of this section has been increased through a two-story frame extension on the rear which contains a passage and stair. The third, westernmost, section of the house is two stories high, and, although two bays wide, is wider than the middle section. It is of timber frame construction with scalloped synthetic wall shingling, and roof extended as a "catslide" to just above the first floor windows on the north side. The roofs of all three sections have been recently recovered with composition shingles, and earlier window sash replaced with 1/1 sash.

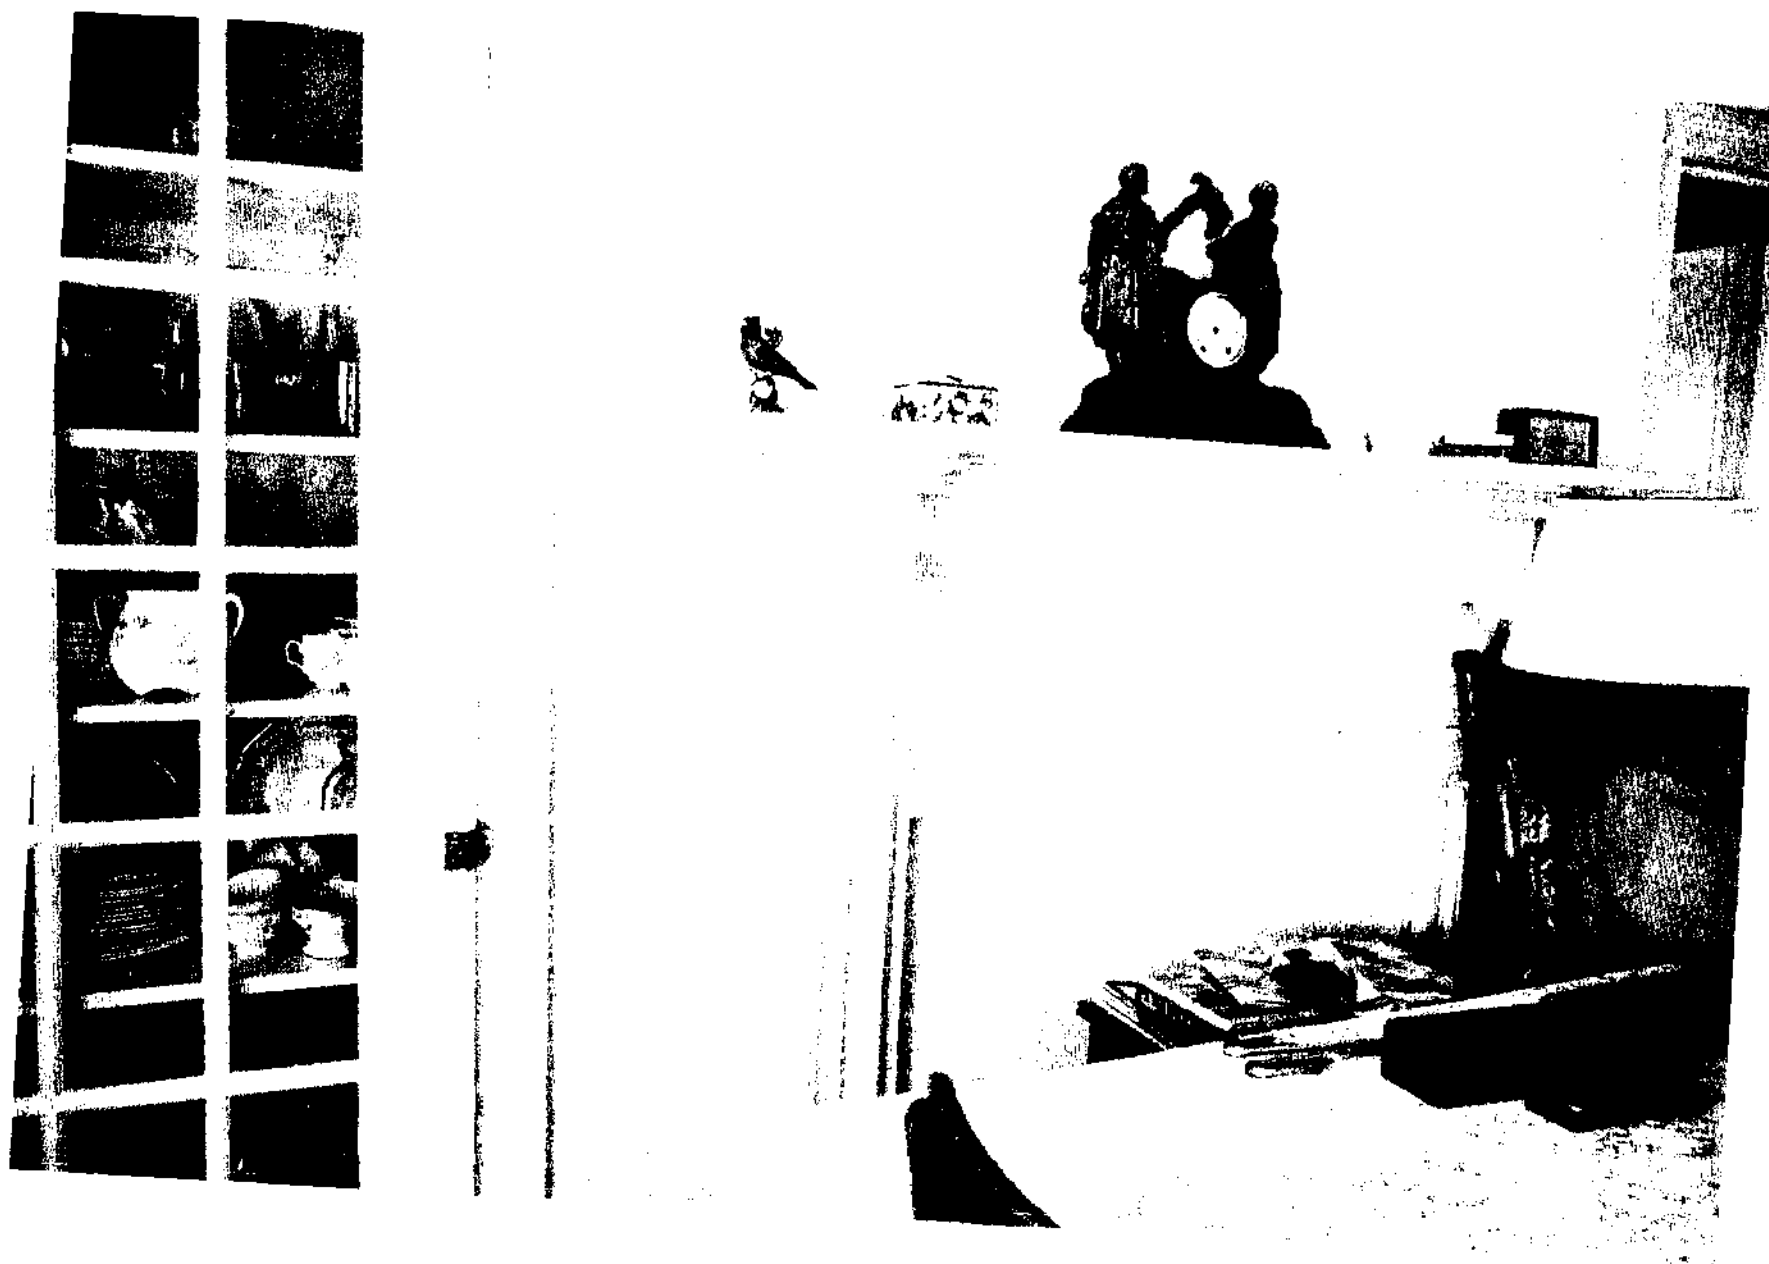
PLATE 18: Cann Farmstead, Mantel at West End of Middle Section, First Floor

The interior is arranged, as the exterior suggests, as a series of rooms opening directly into one another, rather than oriented around a center passage. The house retains a variety of noteworthy interior features, including an enclosed winding stair beside the easternmost chimney, a Federal-style mantelpiece in the first floor room of the central section, deep window reveals with simple moldings, and wide paneled doors with box locks (Plates 18 and 19). The first floor fireplaces in the east section have been remodeled in the 20th century with brick mantelpieces, and are now no longer functional. The kitchen area

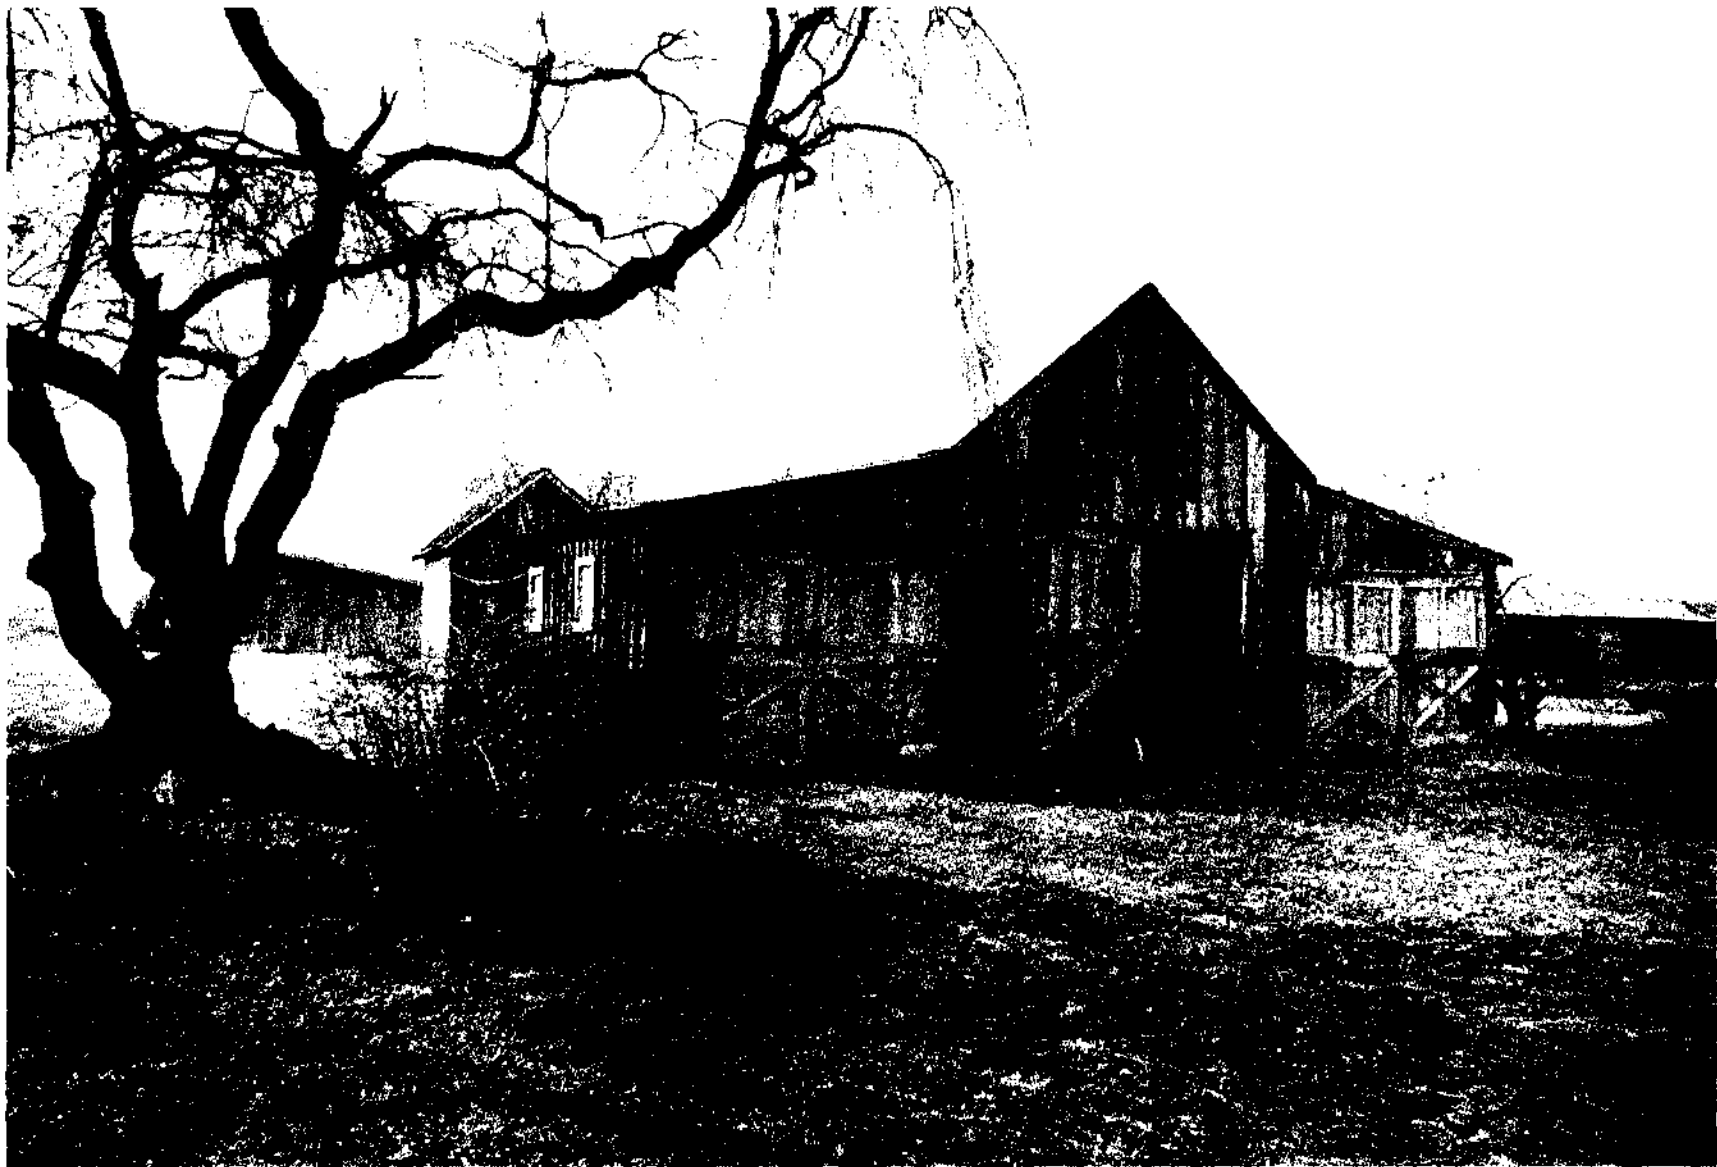
PLATE 20: Cann Farmstead, Garage/Machine Shed, View to West

The outbuildings of the Cann farmstead are arranged in rectilinear fashion extending north and west of the house. Many of these wood frame structures appear to date from the last quarter of the 19th century, in several instances with early 20th century alterations consistent with the property's evolution as a dairy farm. Located directly northwest of the house are a garage with lean-to side extensions, a privy, poultry house and a large gable-roofed crib barn with a very low earthen ramp leading to a gable-end entrance (Plates 20 and 21). North of the farm lane running west from the road to the fields are a hog house, several small corncribs, a six-bay machine shed and another poultry shed (Plate 22). Northernmost in the complex are two large barns set perpendicular to one another and connected by a corrugated metal shed in a L-shaped arrangement (Plates 23 and 24). Both appear to have been originally built as all-timber structures, altered in the 20th century through reconstruction of the ground levels in concrete block for dairy purposes. One barn has been clad in asbestos shingling on three sides, while the other retains vertical plank siding on the upper levels of all four walls. The former barn has a concrete floor and pipe stanchions for milking. The ground level of the latter barn is divided into a series of animal pens.

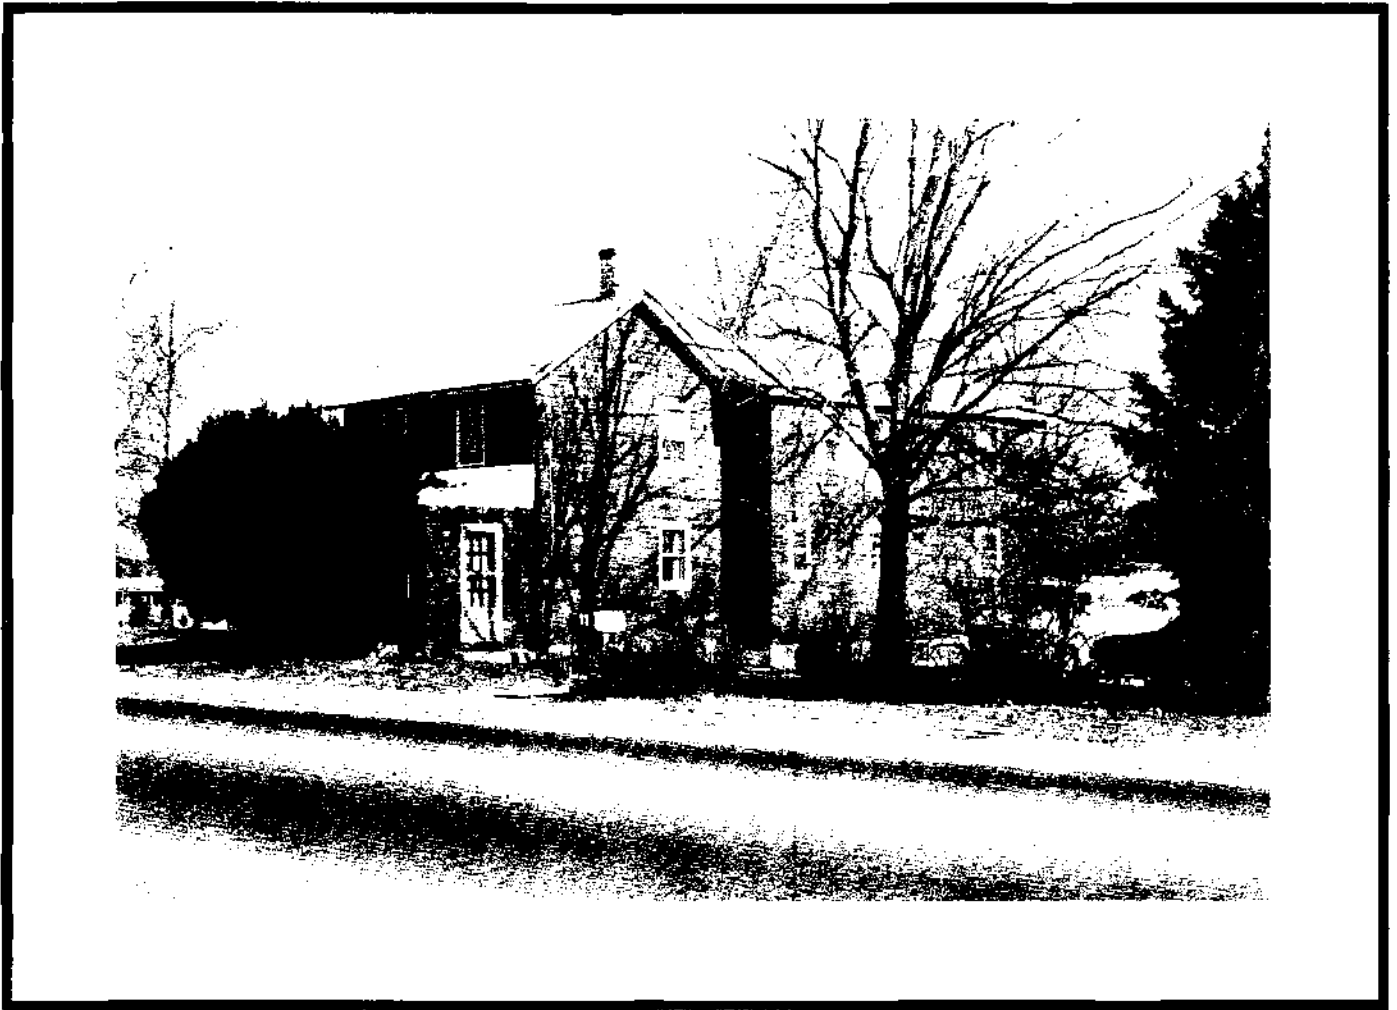
PLATE 25: Early 20th Century Frame House on Route 896, View Looking Northeast

The house is a wood frame structure clad in red aluminum siding (Plate 25). The original block is a two-story, side-gable single-pile I-house on a rubble fieldstone foundation, to which has been added a noticeably large, two-story gable-roofed rear unit with slightly raised concrete basement. A shed-roofed one-

room unit has been built across the original three-bay facade, and the main entrance is now located at the south end of this feature. All windows have 1/1 double hung sash, those of the original block retaining flat plank surrounds with drip shelves. A single brick chimney is located on the roof ridge toward the south gable end.
